CULTURAL RESOURCE MANAGEMENT PLAN

Fayette Historic Townsite

Delta County, Michigan

Final Submission
December 1996

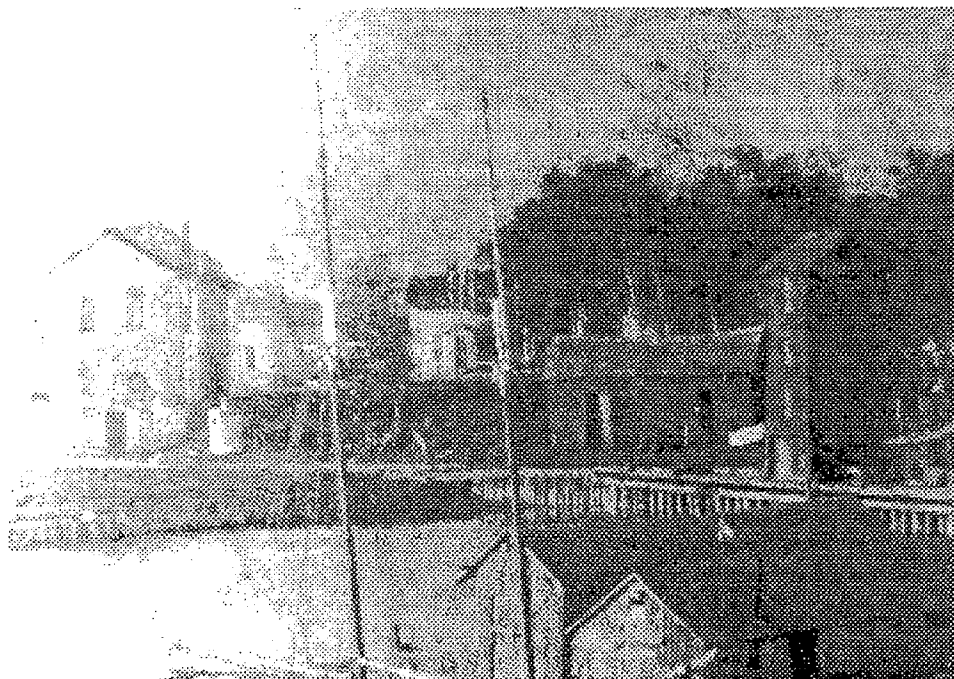
Figure III-7

View looking southwest toward the Icehouse (Bldg. #133) and the Grain Elevator (Bldg. #134) from the harbor near the Dock Sheds (Bldg. #136).

Note: The Icehouse and the Grain Elevator (Bldg. #134) are still in relatively good condition, what is the little shed adjacent to the Town Hall (Bldg. #101)?

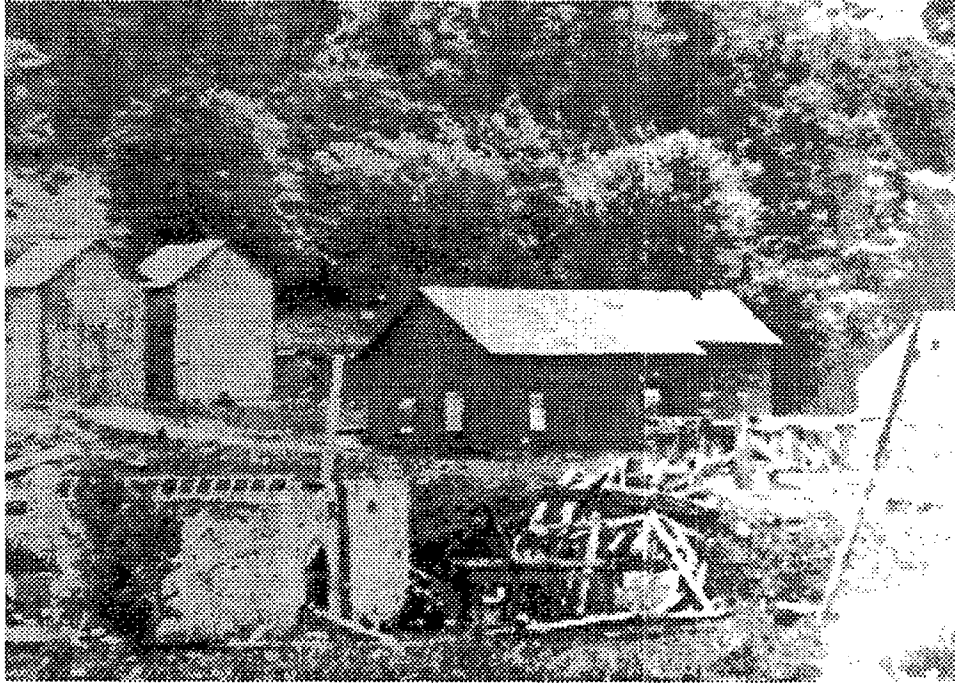
Figure III-5

View looking southeast behind the furnace complex.

Note: The two granaries (Bldg #130) and the railroad Roundhouse (Bldg #132) are still present; however, the train trestle has collapsed and the west casting house of the furnace complex (foreground) is in a state of deterioration. (Is the building at the right of the photograph the jail?)

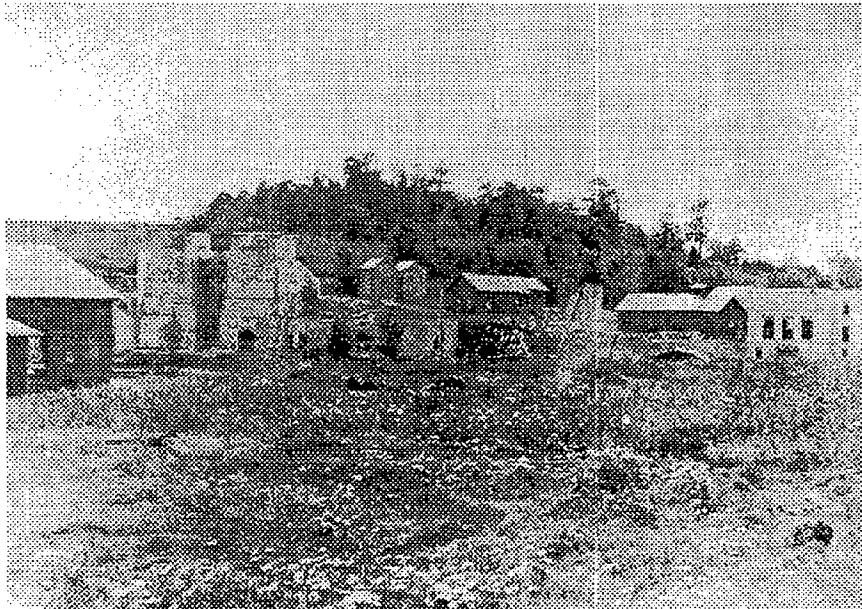
Figure III-6

View looking southeast at the furnace complex and surrounding buildings.

Note: The train trestle has collapsed; the granaries (Bldg. #130), the railroad Roundhouse (Bldg. #132), and the Blacksmith Shop (Bldg. #103, adjacent to machine Shop) adjacent to the Machine Shop are all still present; also note the wood frame building in the left foreground which appears to be the Sawmill (Bldg. #135).

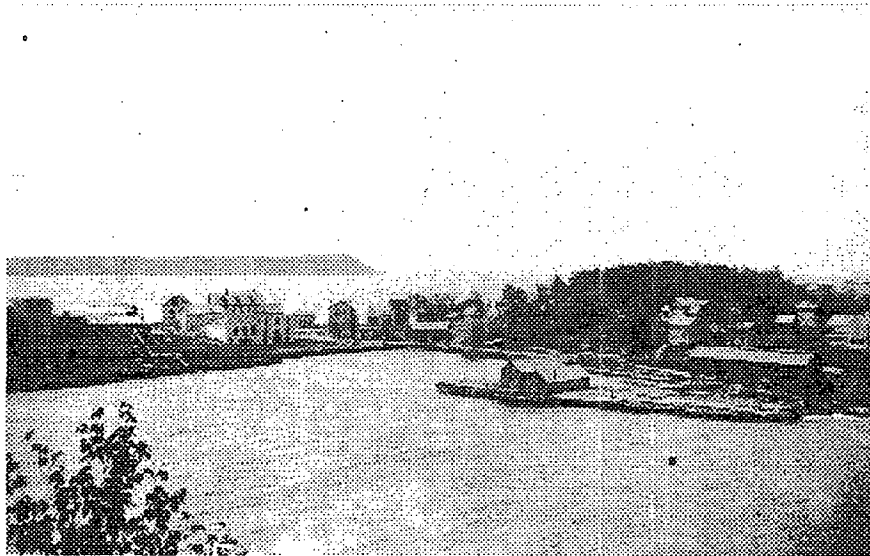
Figure III-1

View looking southwest across Snail Shell Harbor toward the townsite.
Note: Furnace complex is in state of deterioration; buildings on either side of the Hotel (Bldg. #100) are still there; several buildings that were gone by the 1907 survey are still present including the Sawmill (Bldg. #135) and the Ice House (Bldg. #133).
Date: ca. 1891 - 1910s

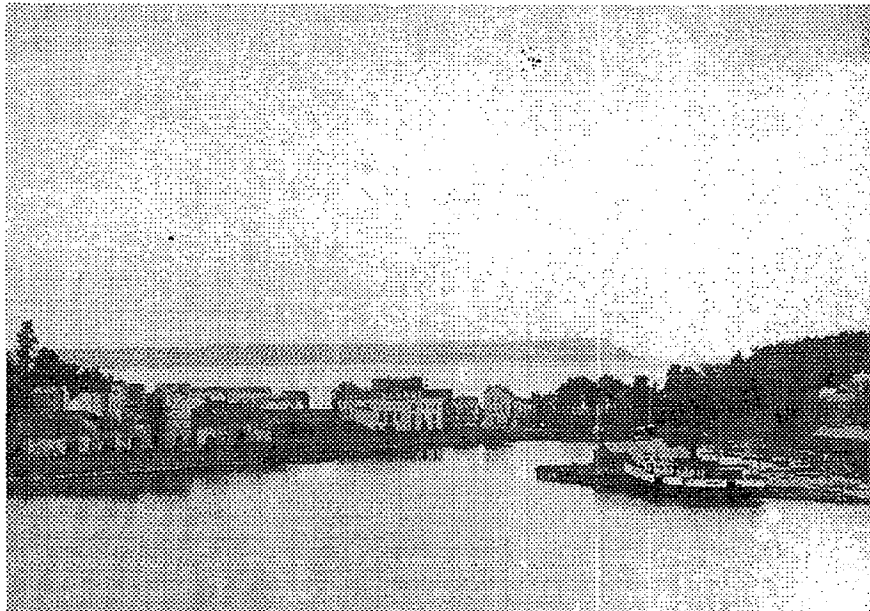
Figure III-2

View looking southwest across Snail Shell Harbor toward townsite.
Note: The roof of the west casting house has deteriorated; several buildings that were gone by the 1907 survey are still present including the Sawmill (Bldg. #135) and the Ice House (Bldg. #133).
Date: ca. 1891 - 1910

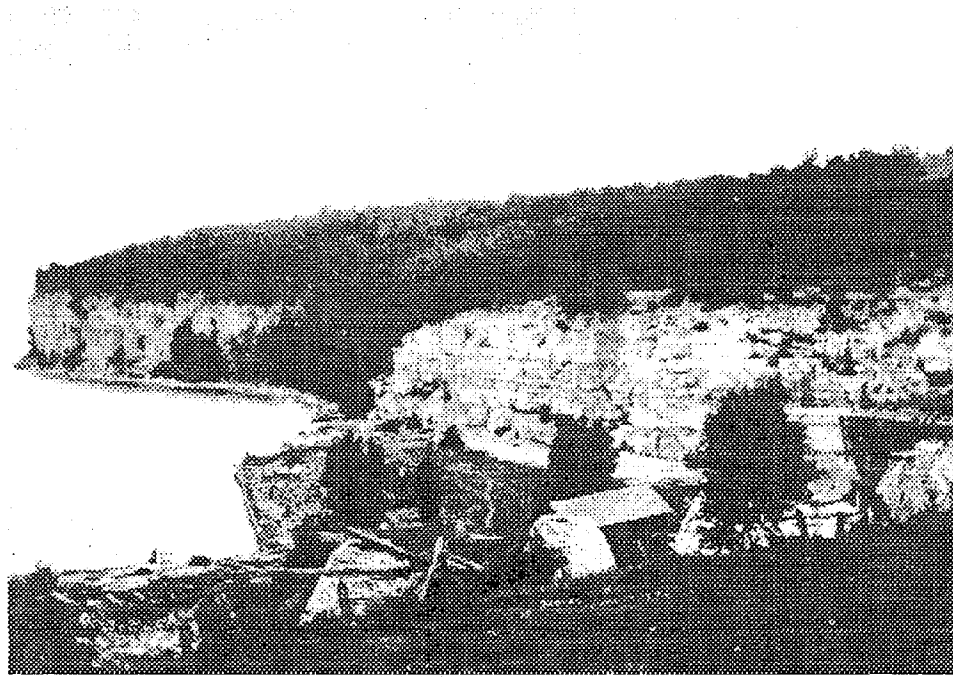
Figure III-13

View looking northeast from furnace hill toward the limestone bluffs.

Note: The walkway above the charcoal kilns has deteriorated; however, the Hay Barn (Bldg. #128) and the small wood frame shed (not assigned a building number) near the lime kiln are still present.

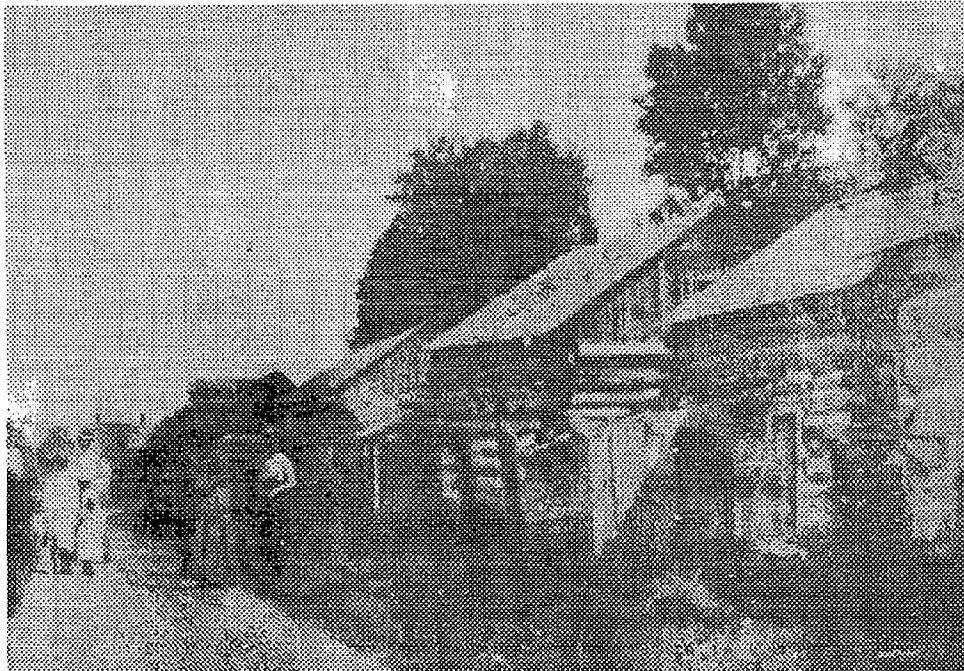
Figure III-17

View looking north at the workers' cabins.

Note: The location and orientation of this photograph can be determined using the hotel (in the background) as a reference; the cabin's are deteriorated; the people in the photograph appear to be from the 1907 survey group.

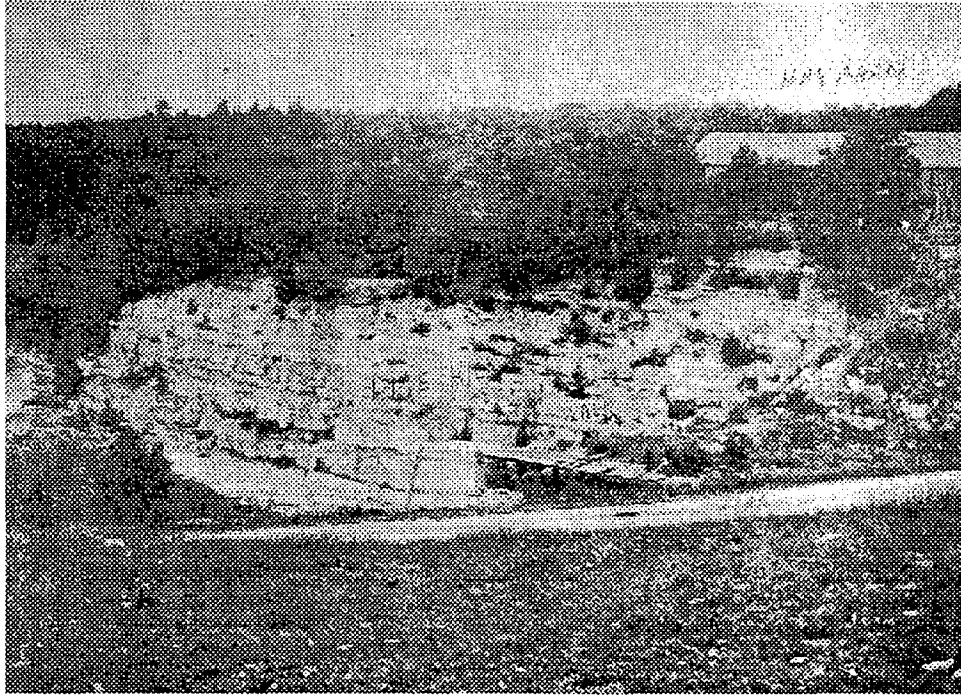
Figure III-21

*View looking down from "Furnace Hill" toward the limestone bluffs and lime kiln (Bldg. #125).
Note: The upper walk to the lime kiln has deteriorated; the hay barn (Bldg. 128) is still there.
Date: 1907 - 1920*

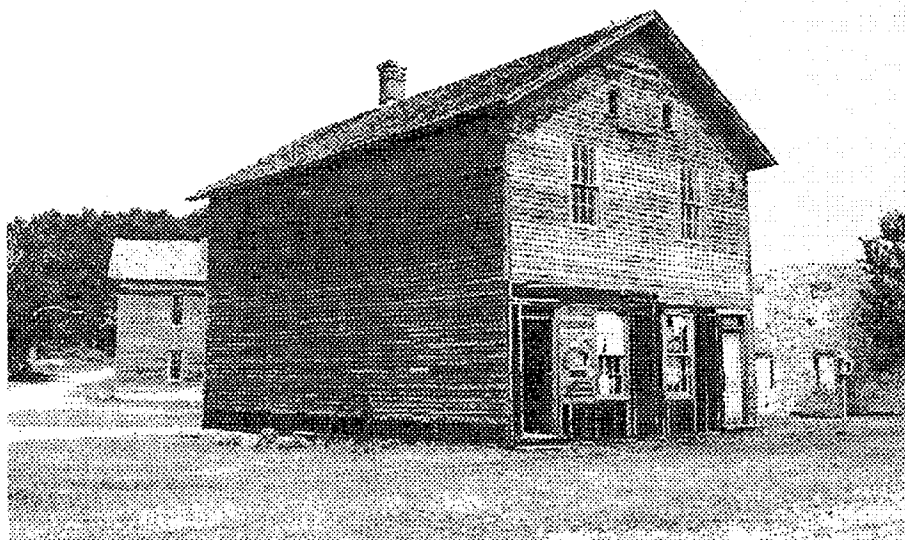
Figure IV-4

View of the Company Office, (Bldg. #108) during restoration work.

Note: The east elevation has been returned to its original configuration and the deteriorated sill has been replaced.

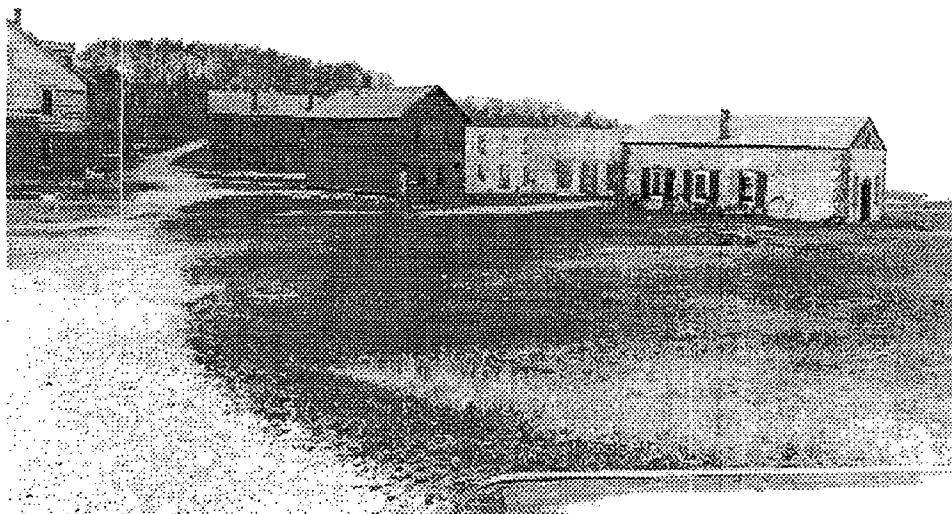
Figure IV-9

View looking northwest into the town center.

Note: Several structures have been lost to deterioration; the reconfiguration of the fenestration at the east elevation of the Company Office (Bldg. #108) has already taken place.

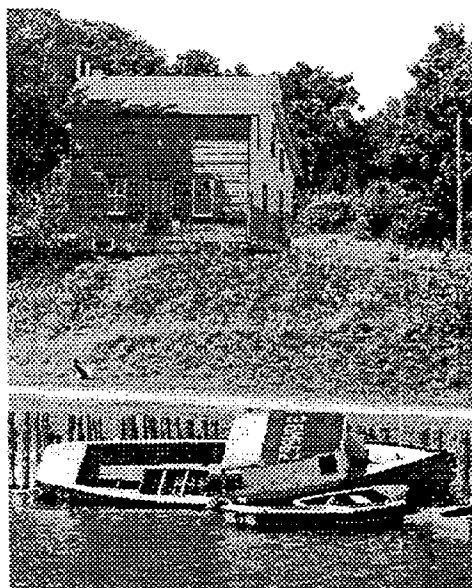
Figure IV-10

View of a company supervisor's residence (Bldg. #4)

Note: The docks have deteriorated extensively; the sill plate and subsequent clapboard replacement has taken place at the building. The chimney has been constructed, part of the alterations to use it as the park manager's residence.

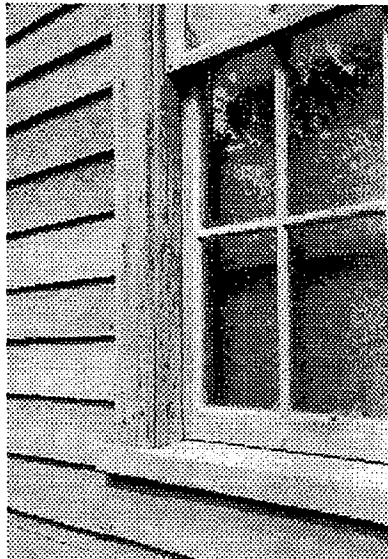
Figure 15

Most of the wood window sashes have been replaced at the Supervisor's Residences located along the back street (Buildings #18, 25, 26, and 27). These replacement sashes are appropriate according to historic photographs, but they were not installed properly. It was observed at several of the window openings that the bottom stop was partially removed and, subsequently, that the sash does not close properly (kicking out at the bottom). *Figure 15* shows a full stop and proper sash closure, and *Figure 16* shows a typical window where a portion of the stop has been removed.

Detail view of a window with full stop, 1996.

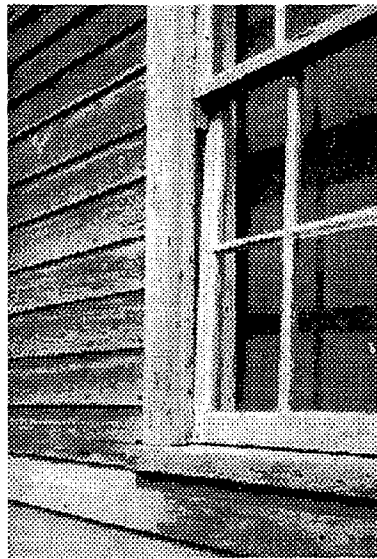
Figure 16

Detail view of a window that the bottom portion of the stop has been removed, and the sash is "kicking out," 1996.

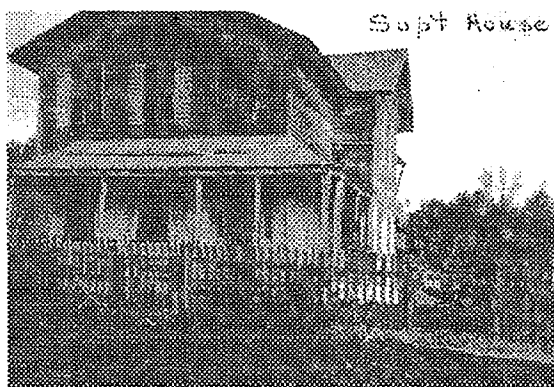
View of the south elevation ca. 1907. Note the curved profile metal roof, shutters at the second floor windows, and picket fence.

- Construct and install historically accurate (based on photographic evidence) shutters at all of the windows where they were originally located.
- Remove the existing south porch and reconstruct with historically appropriate materials and configuration, based on evidence found in historic photographs. This includes reconstructing the porch roof with a sweeping slope as seen in Figure 17 rather than the existing straight-line slope; reconstructing historically appropriate porch columns in historically appropriate configurations and locations; and the original porch did not extend to the west edge of the facade.

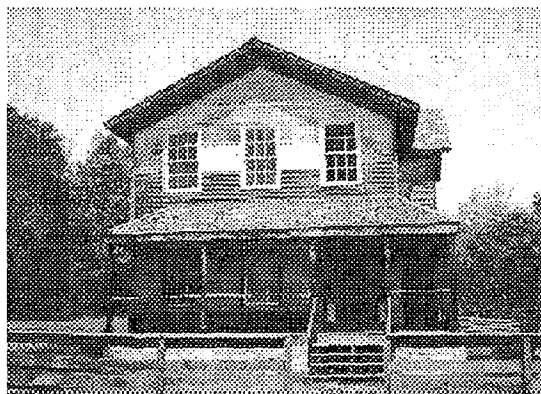
Figure 18

View of the east elevation in 1996. Note the reconstructed rail fence, there are no shutters on the house, the wood shingled porch roof, and the metal handrail between the porch columns.

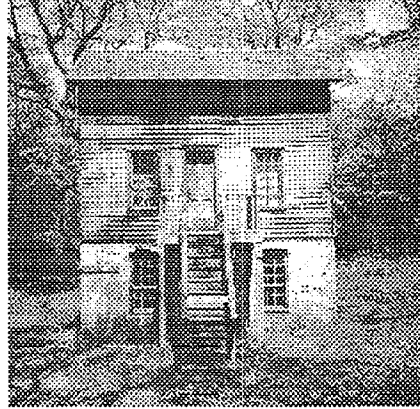
Figure 22

Both of the second floor porches have wood stairways leading to grade and have been reconstructed with historic accuracy (Figure 22). The stairs, which had already been reconstructed once (however, it was not the appropriate size, as they extended the entire width of the building) were in a dilapidated condition during the 1961 survey. Drawings for their historically appropriate reconstruction were produced in 1961. Since their reconstruction, portions of the balustrades and handrails, and a few treads have deteriorated, which was likely caused by the absence of a protective sealant or finish on the wood. The 1961 drawings also contain a detailed schedule for window replacement. Three new wood sashes were observed at the second floor. The door sill at the ground floor door of the north elevation has rotted.

View of the south elevation in 1996. Note the exterior stair has been reconstructed (this is at least the second reconstruction). Also note that overgrown vegetation has been cleared away from the building.

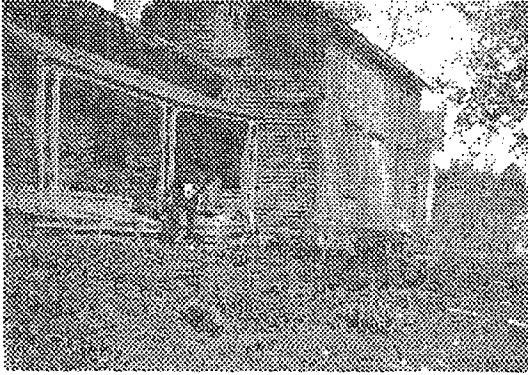
Figure 26

No physical evidence was observed above grade of the former one-story wing that was attached to the south end of the house (Figure 26). However, future archeological investigation may reveal evidence of it.

View of the east elevation in 1907. Note the one-story addition at the south with porch extending its entire length. (This addition and porch have since disappeared.)

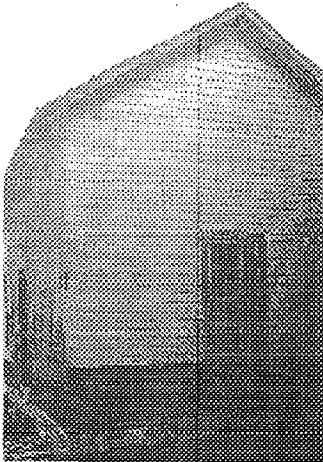
Figure 46

View of the north elevation, ca. 1960s. This photograph was taken during the sill replacement. Note that the clapboard siding has been removed from the east elevation.

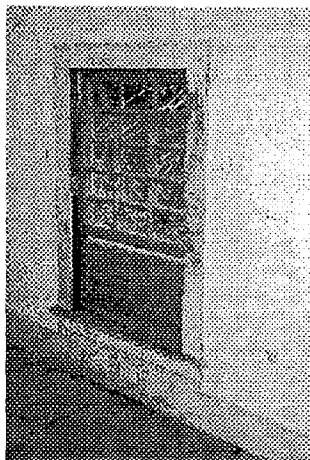
Figure 54

Physical investigation revealed that the interior of the building has accumulated an extensive amount of moisture, resulting in the deterioration of the plaster walls and ceilings, and the growth of mold and fungus. The basement window at the west elevation, and the lower portion of one of the second floor windows at the east elevation, have had wood vents installed to provide ventilation into these otherwise closed spaces. The combination of limited vegetation scrubbing and a wood louvered vent, which was installed in one of the rear windows of second floor, has also decreased moisture accumulation within the building (Figure 54). The stair leading to the basement has been removed.

View of one of the second floor windows at the rear (east end) of the building, 1996. Note the wood louver vent installed in the bottom portion of the opening.

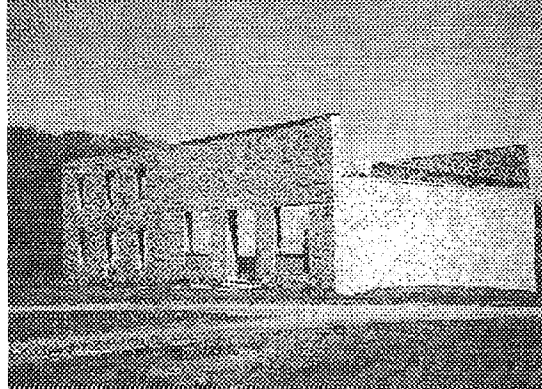
Figure 71

View of the south and east elevations, 1998. Note that the walls, especially near the top and near openings have been stabilized and capped with limestone.

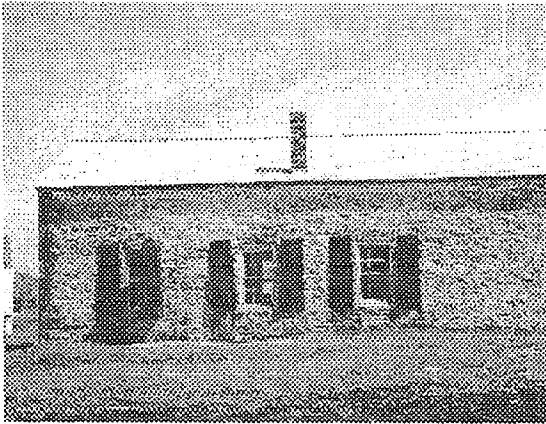
Figure 72

View of the south elevation, 1996. Note that the top of the limestone wall (can see lighter mortar color) has been reconstructed and the roof.

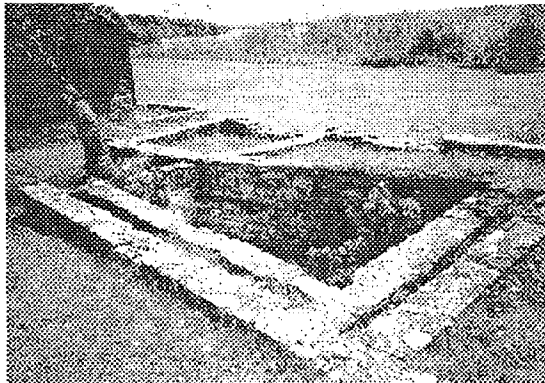
Figure 80

Physical observation revealed that vegetation is growing on top of several areas of the foundation walls. In addition, large trees have grown within the perimeters of the foundations (Figures 80 and 82). In several areas, the vegetation has damaged these ruins. Furthermore, earth pressure against these walls has resulted in bowing and sagging in several areas. The current slope of the grade adjacent to several of the foundations facilitates drainage toward the walls rather than away from them, which is preferred.

Foundation of a Supervisor's Residence (Building #8).

It is recommended that all detrimental vegetation be "scrubbed" adjacent to all extant buildings, especially those buildings that are not open to the public. This will help to mitigate continued mildew growth on the wood surfaces and moss on the roofs. Most of this growth is thought to have been the result of a lack of sunlight or ventilation due to the overgrown vegetation, especially on the north sides of the houses along the back street (Buildings #18, 25, 26, 27, and 30/31). This treatment is important, especially as more and more historic fabric is restored and refinished. The "scrubbing" should maintain vegetation at a minimum distance of 10 - 15 feet from each building. It is also recommended that vegetation scrubbing from the extant foundations ruins be continued on a yearly basis.

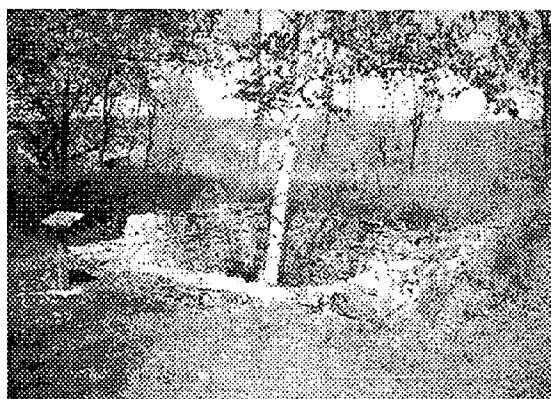
Figure 82

Foundation of the Boarding House (Building #5)
